DOT/FAA/AR-99/6

Fiber-Reinforced Structures for Turbine Engine Rotor Fragment Containment

September 1999

Final Report

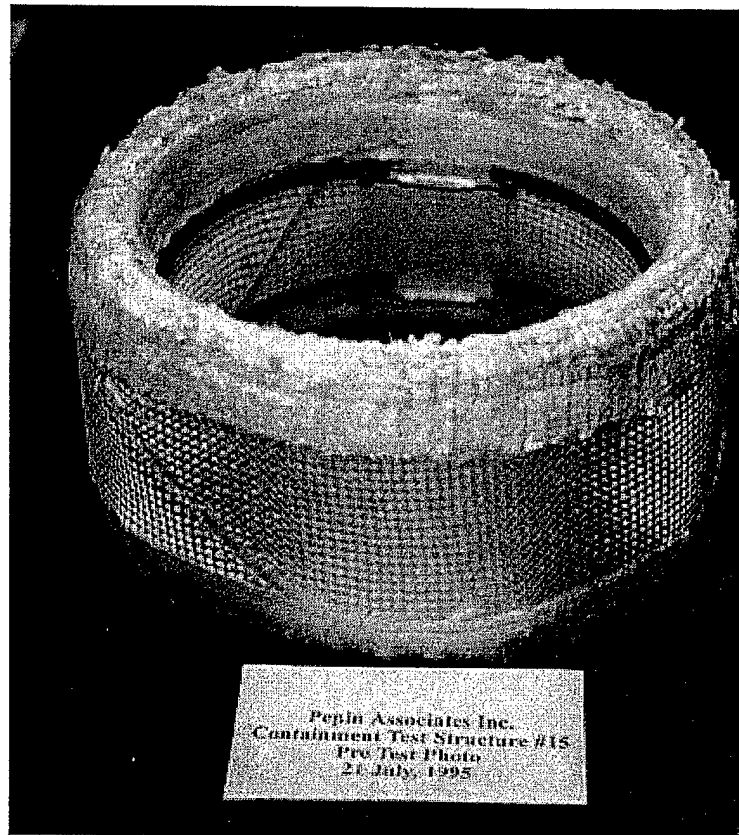
FIGURE 6. S GLASS RING WITH $\pm 45^\circ$ REINFORCEMENT

the ring and the entire edge was sewn through to bind it together. As the ring was impacted along its central plane by the disk fragments, the containment ring expanded radially, and the ring shrunk in height due to the fiber architecture. The edges of the ring, however, were more restricted in their ease of radial expansion because of the $[0/90]$ strips. This created a pocket in the ring which prevented the disk fragments from flipping out of the stretched ring.

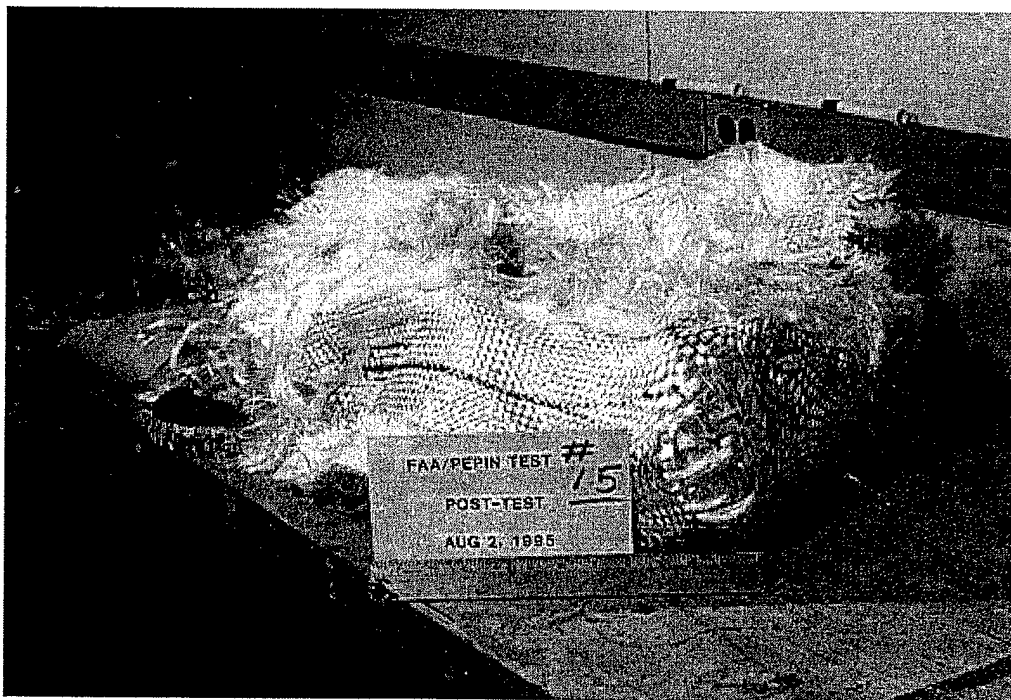
FIGURE 7. POSTTEST PHOTO OF S GLASS RING WITH $\pm 45^\circ$ REINFORCEMENT

The S Glass ring with $\pm 45^\circ$ reinforcement did not contain the rotor burst. One of the disk fragments penetrated the ring wall while the other two remained within the ring. Figure 7 is a posttest photo of this ring.

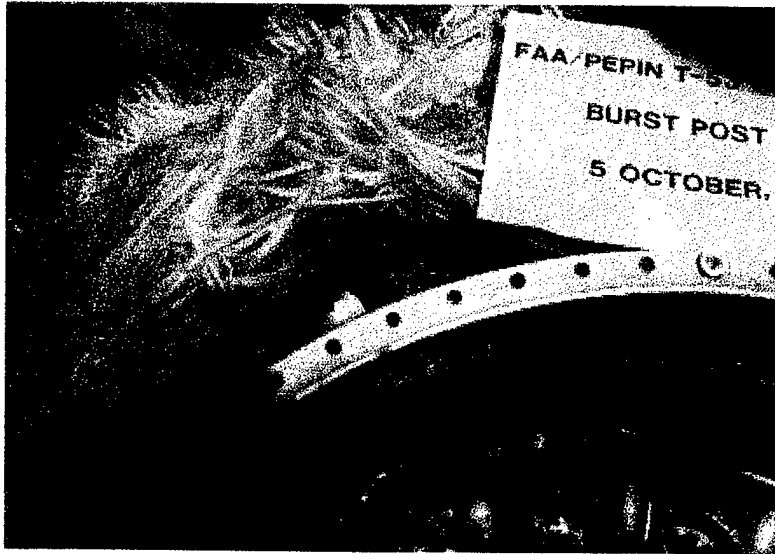
FIGURE 19. CLOSE-UP PHOTO OF AREA BETWEEN COMBUSTOR CASE AND CONTAINMENT RING AFTER TEST OF FIRST LARGE-DIAMETER KEVLAR CONTAINMENT RING

This ring was tested with the engine combustor case suspended in the spin test chamber. The containment ring completely contained the rotor burst with no penetrations of the witness ring. The trigger strip for the high-speed flash lamps was located on the containment ring ID so the first photo shows the disk fragments partially penetrated into the engine combustor case. Figure 18 shows the high-speed sequence of photographs as the disk fragments impacted the containment ring. The three disk fragments were trapped between the outer case skin and the containment ring. Figure 19 shows a close-up photo of this area.

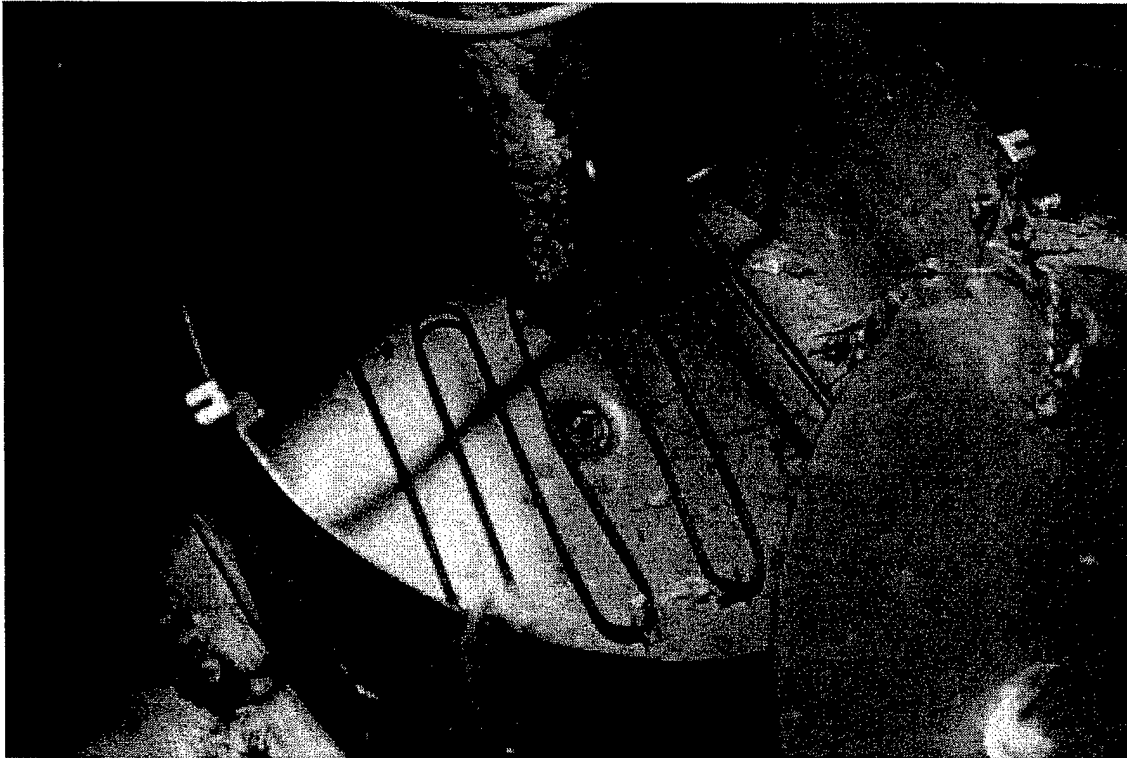
FIGURE 29. OVEN USED TO HEAT THE THERMAL TEST RINGS JUST BEFORE SPIN TESTING

the ring and acted as a witness shield. Two shallow dents were found in this sheet but no holes were found. Figure 27 shows the ring mounted to the spin chamber cover but the oven has not yet been placed over it. Figure 28 is a posttest photo and figure 29 shows the heating element inside the oven.

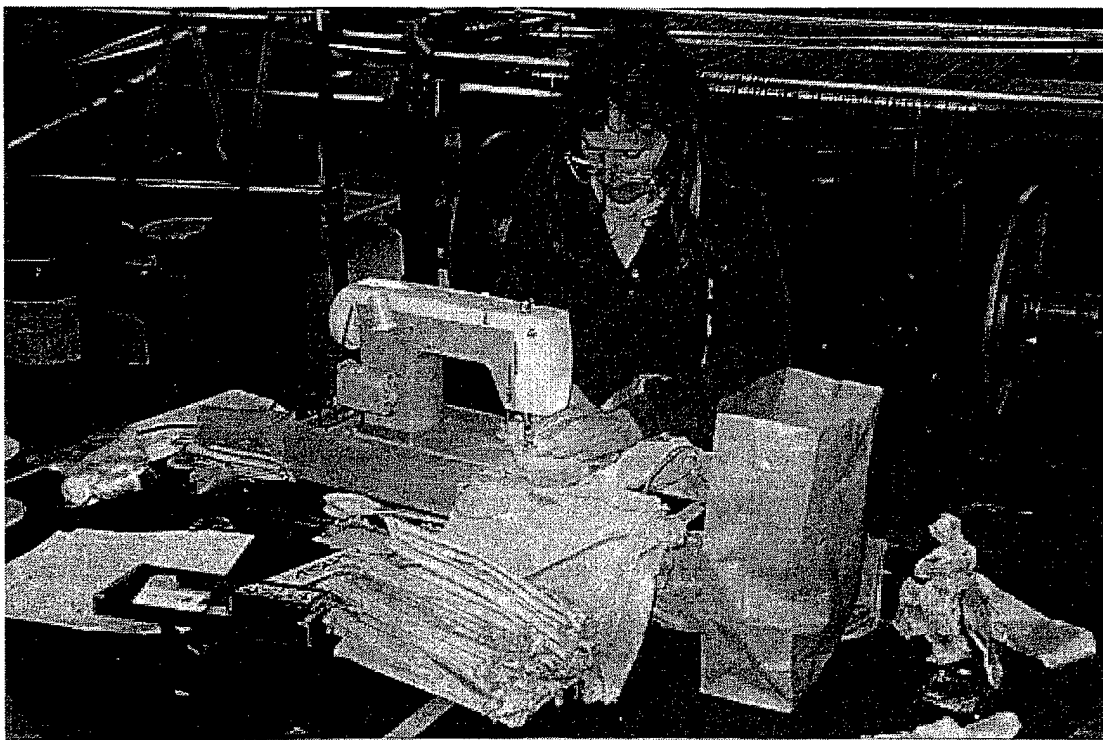
FIGURE 32. SEWING DRAW STRING STRIPS TO EDGE OF FABRIC

The PBO fabric used for this test ring was a 16 x 16 plain weave with 3000 denier unsized but twisted yarns. Since the tows were available only in the unsized condition, they were twisted so they could be easily woven. Fabric weight was 0.439 kg/m². This ring had 43 plies with the same layup and architecture as the Kevlar thermal test ring previously described. As with the previous ring, no rods or facesheets were added. The mass of this ring was 5.73 kg and it had the following dimensions: ID 38.10 cm, OD 43.78 cm, and axial length 24.13 cm. Figures 30 through 33 show the cutting and sewing steps required to build the ring, and the finished ring is shown in figures 34 and 35.

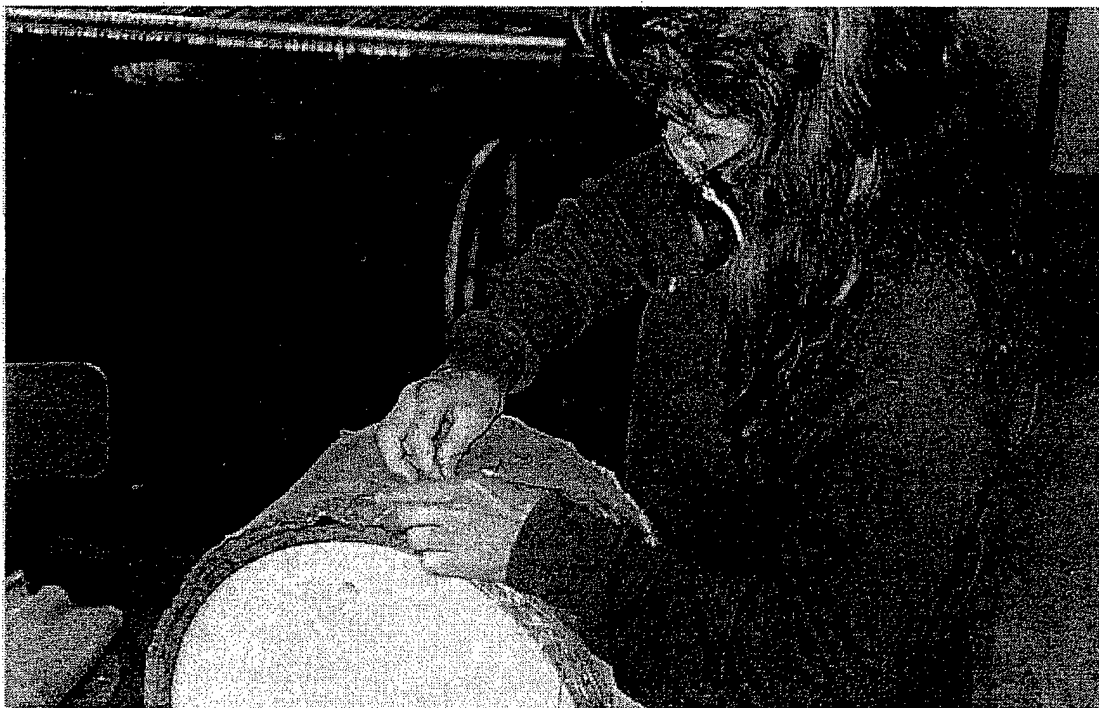
FIGURE 33. LAYUP OF PBO CONTAINMENT RING

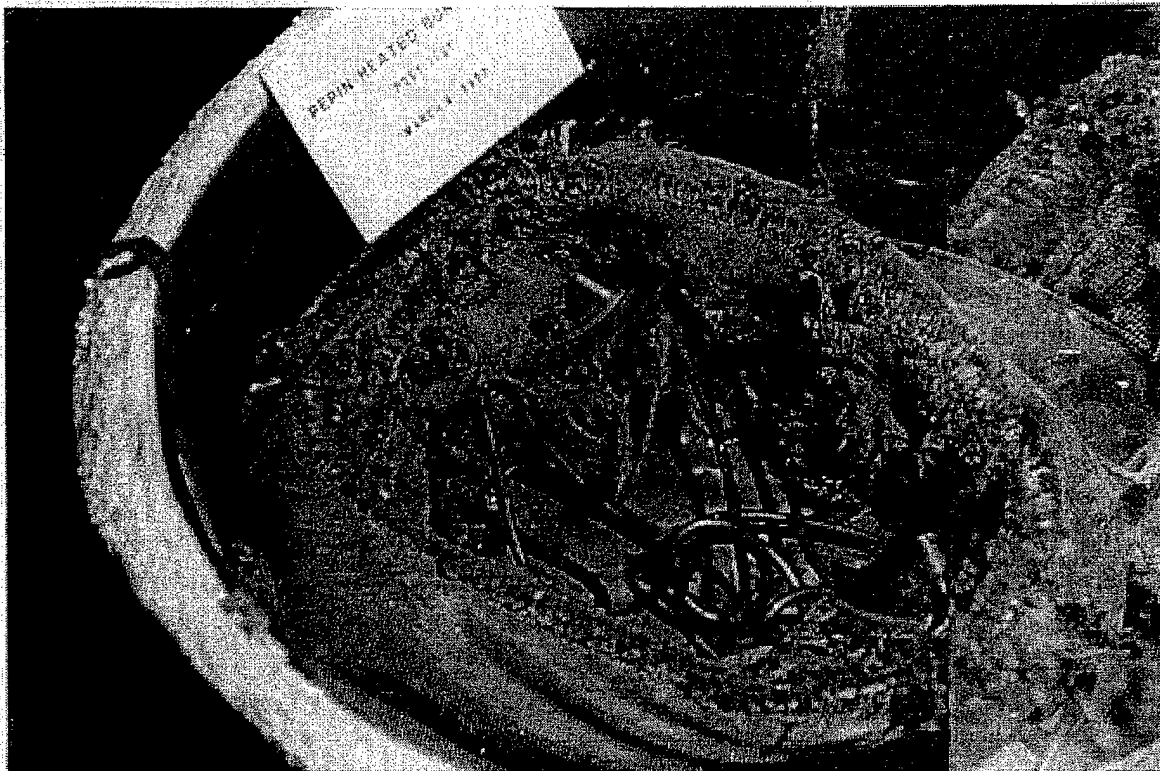
FIGURE 36. POSTTEST PHOTO SHOWING PBO RING, FRAGMENTS, AND HEATING ELEMENTS

The rotor failed at 20,200 rpm and the ring contained all the fragments. The deepest penetration by one of the disk segments was 41 plies leaving only 2 plies undamaged. Thus, this design at the 200°C temperature was close to the threshold of containment. Figures 36 and 37 show the posttest condition of the PBO thermal test ring.
